Manhole Inspection Summary

Manhole # S25EE1032MH

Location Address: **3912 FALLS RD**

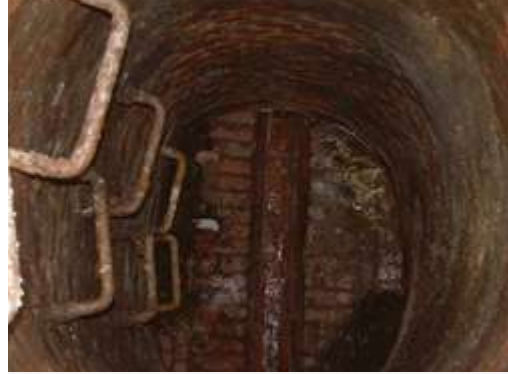
Top View

Evidence of surcharge - Bench debris.
Corroded steps.

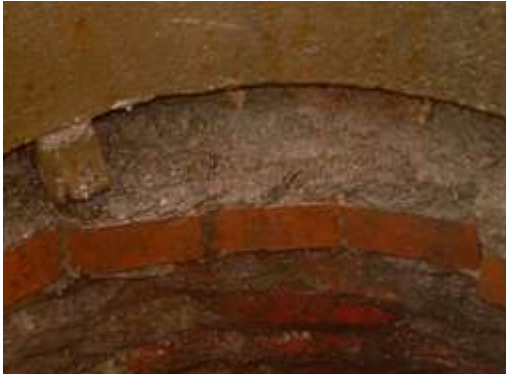
Defect

Frame leaks. Adjustment loose bricks,
deterioration, and infiltration.

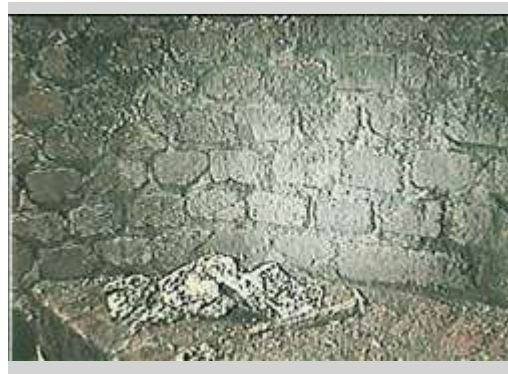
Defect

Barrel deterioration and infiltration.

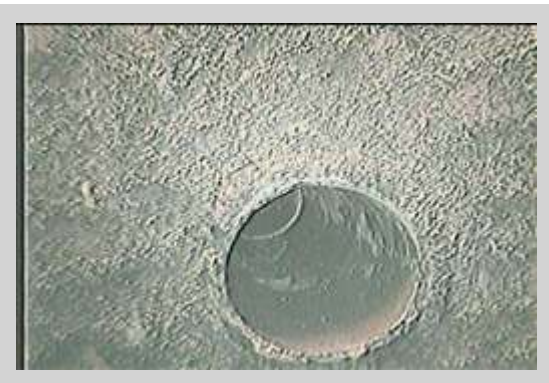
8 in. Circular Gravity Sewer Pipe In @ 6 O'Clock

Infiltration: **Evidence** Pipe Seal Cond: **Unknown**
